S-173
Thomas Sudler Farm
Near Westover
Private

**Maryland Historical Trust
State Historic Sites Inventory Form**

Survey No. S-173

historic Thomas Sudler Farm

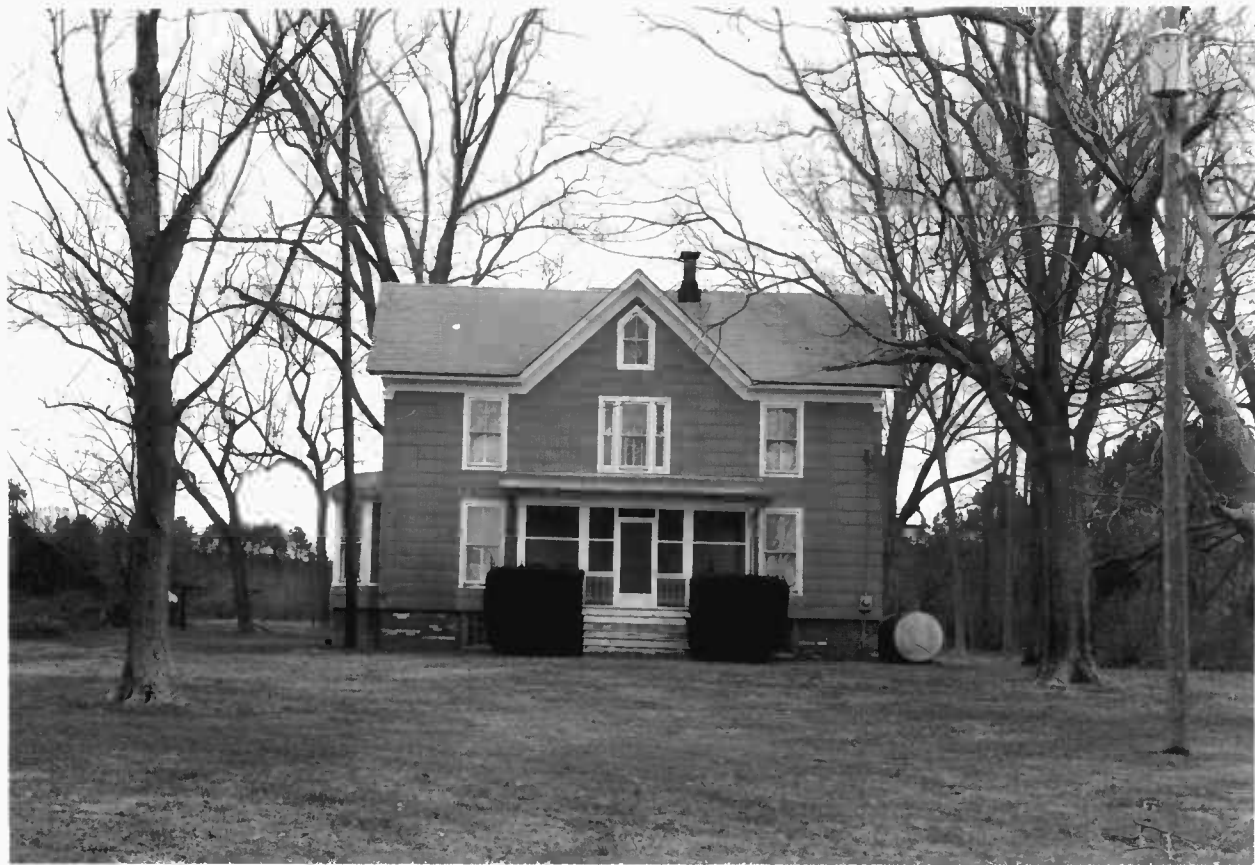
S-173

Thomas Sudler Farm
Near Westover, Somerset County
North Elevation
2/84 Paul Touart
Neg./Md. Historical Trust

Centered in the mowed yard is a c. 1860-1880 two-story three-bay cross-gabled farmhouse which rests on a raised common bond brick foundation and is covered by a steeply pitched asphalt tile roof. The exterior of the T-shaped farmhouse is uniformly sheathed with asbestos siding.

The north (main) facade is symmetrically arranged with a center entrance and flanking 2/2 sash windows. A transom and side-lights surround a molded four-panel door. A shed porch covers the entrance bay with the roof supported by champhered posts. Sawn balusters remain between the posts. Two over two sash flank the entrance bay. The second floor is pierced by a sidelighted 2/2 sash window in the center and flanking 2/2 sash. Featured in cross-gable is a pointed 2/2 sash window. The dentiled capitals of the covered corner pilasters remain on each upper corner. One center brick chimney with corbelled cap rises above the roofline. The east stack has been taken down.

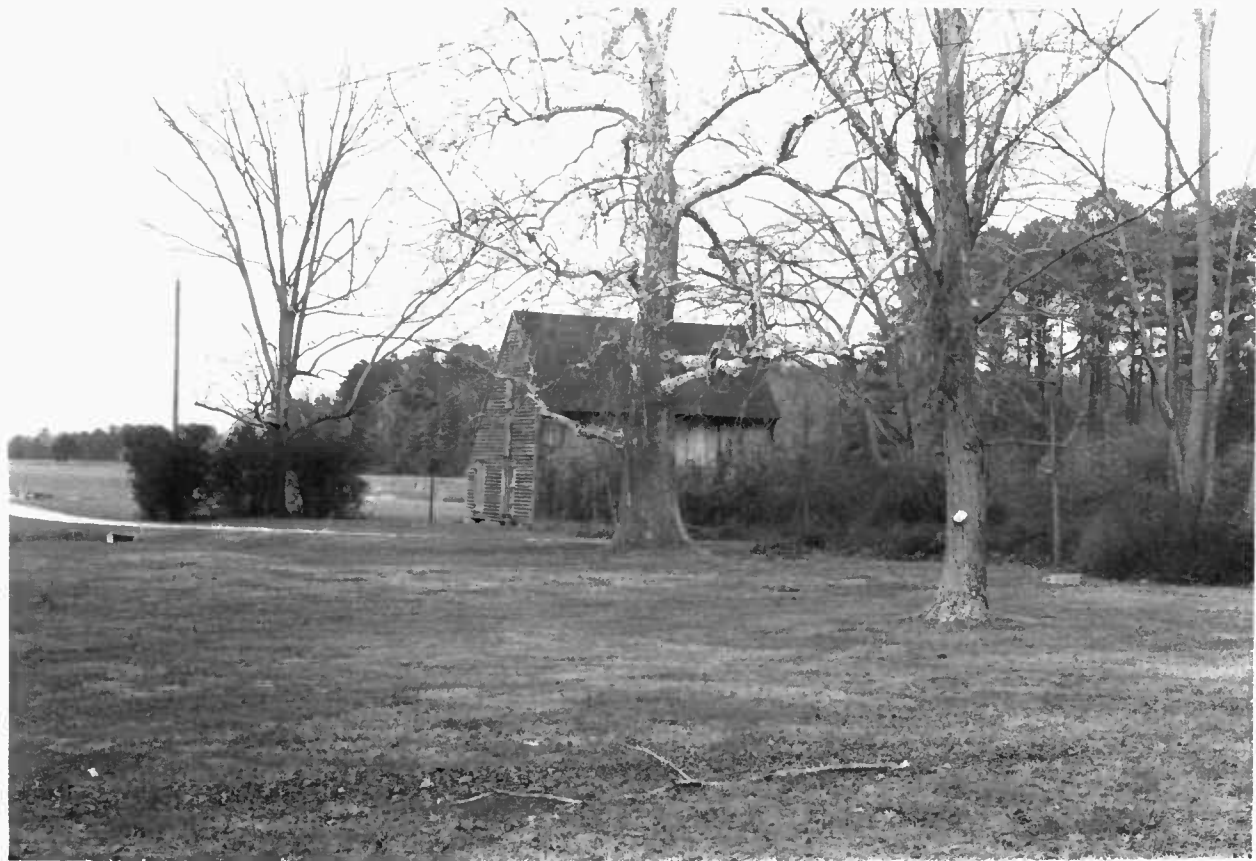
S-173

Thomas Sudler Farm
Near Westover, Somerset County
South Elevation of Tobacco House
2/84 Paul Touart
Neg./Md. Historical Trust

Standing northeast of the house is a bi-level wrought-nail frame barn with one surviving shed on the north side. The south shed, according to the owner, was of later date. From a series of sheared nails on the outside face of the interior stud wall, it appears the north shed was a later addition with the original gable front barn consisting of the center rectangular core. Around the mid-19th century, a new floor was added to allow for grain storage. According to the owner, the barn was

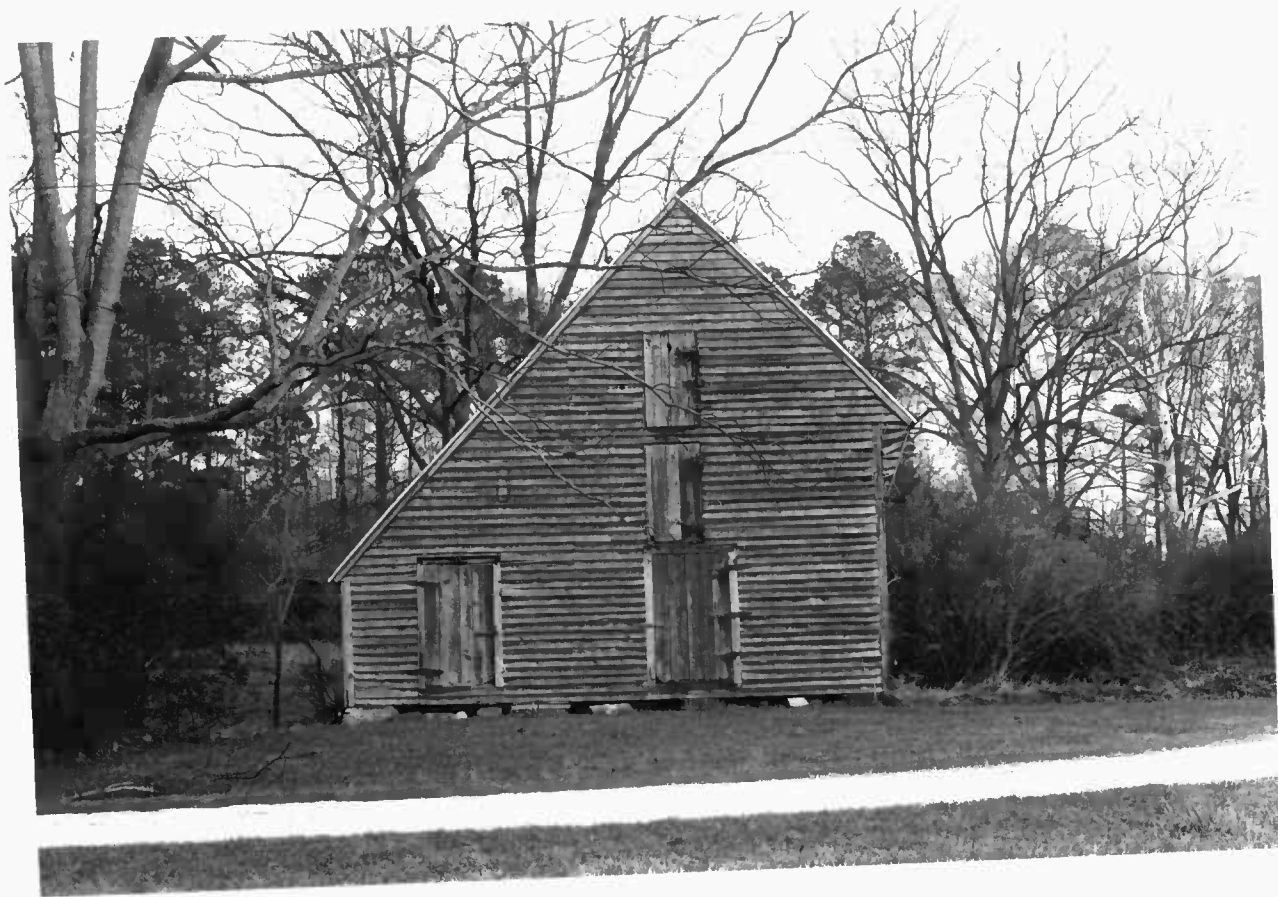
S-173

Thomas Sudler Farm
Near Westover, Somerset County
Barn - West Elevation
2/84 Paul Touart
Neg./Md. Historical Trust

refitted to store hay instead of tobacco. When the middle floor was added, the original floor joists were sawn out to allow for more head room on the second floor. This action sacrificed the original stability of the common rafter roof system. Two tiers of collar beams are let into the rafter pairs with half-dovetailed lap joints. The eave construction for the barn is similar to that of the smoke house with a flat false-plate and pins dropping through the plate as well as the ends of the floor joists.

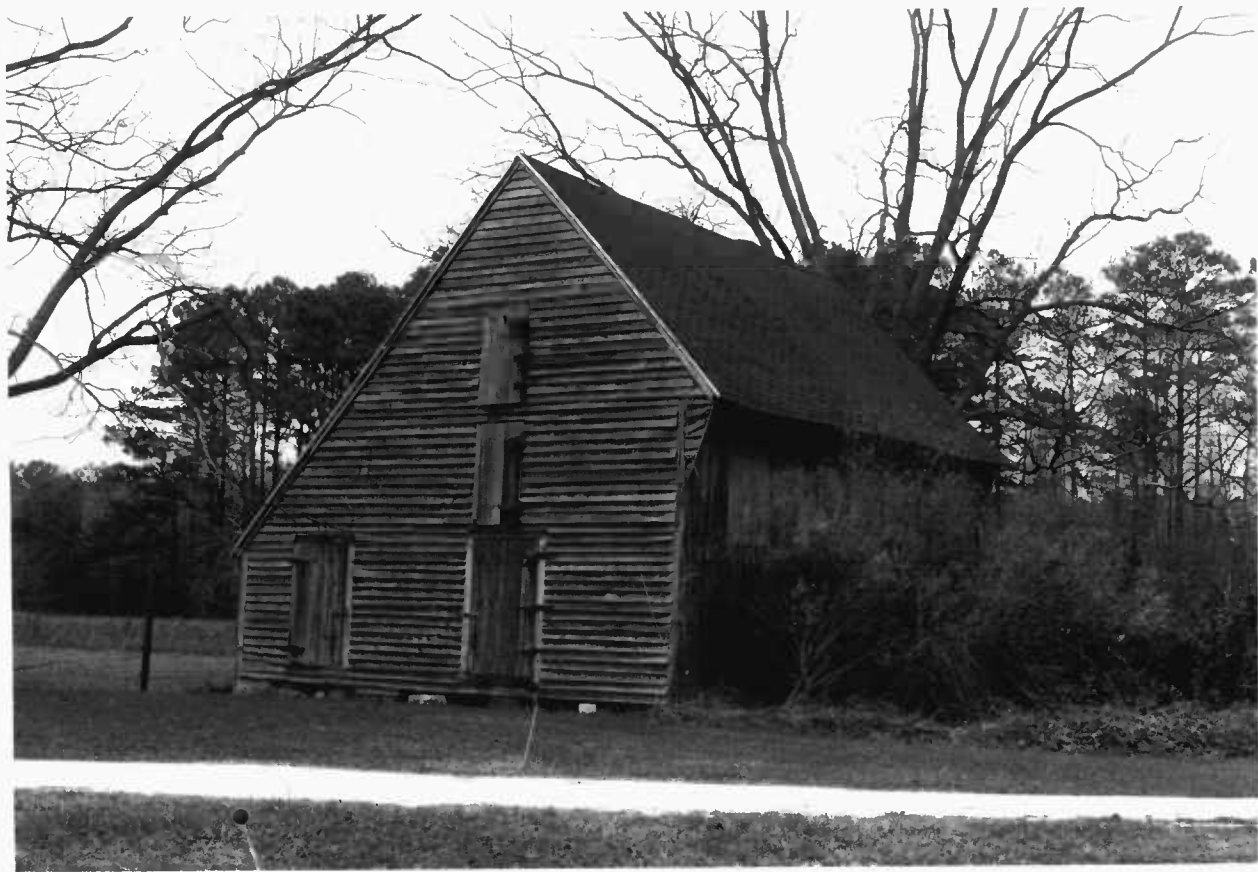
S-173

Southwest Elevation

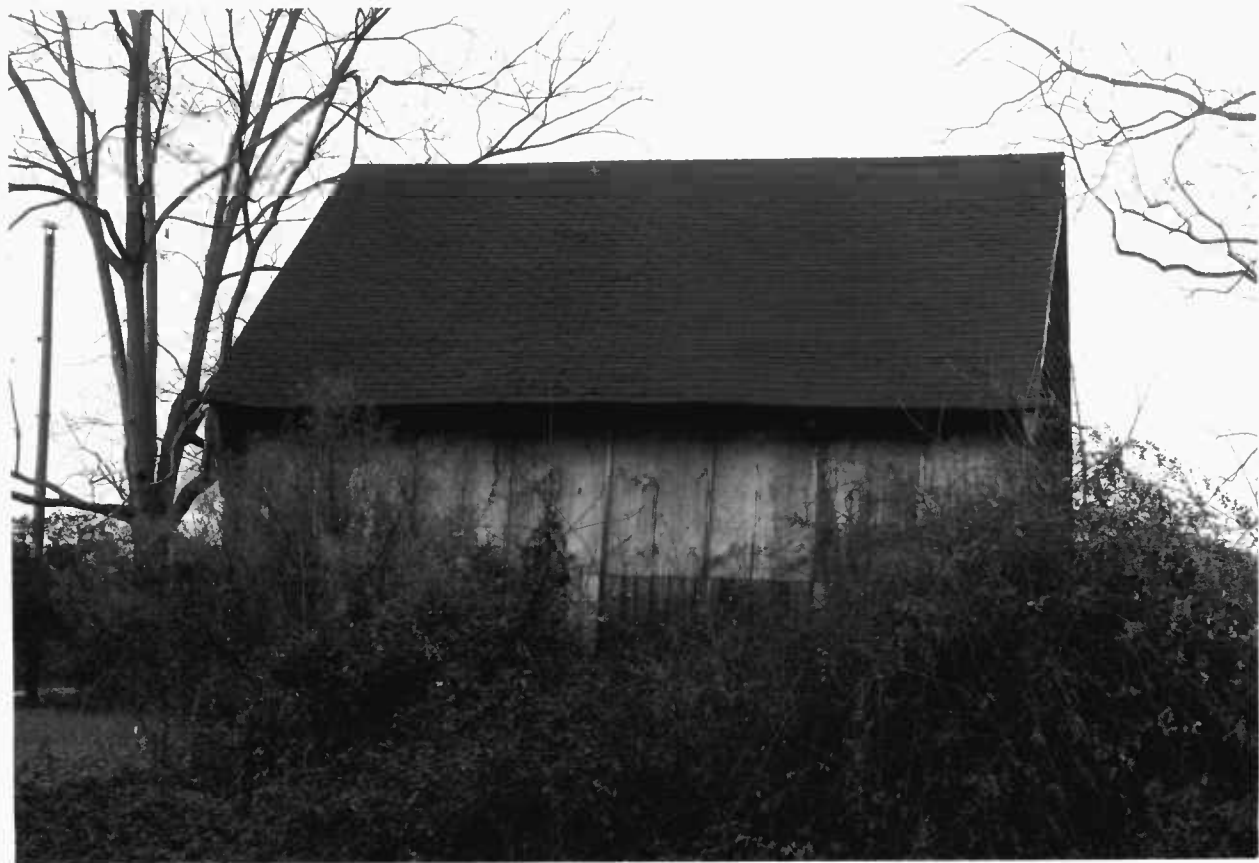
S-173

Thomas Sudler Farm
Near Westover, Somerset County
Barn - South Wall
2/84 Paul Touart
Neg./Md. Historical Trust

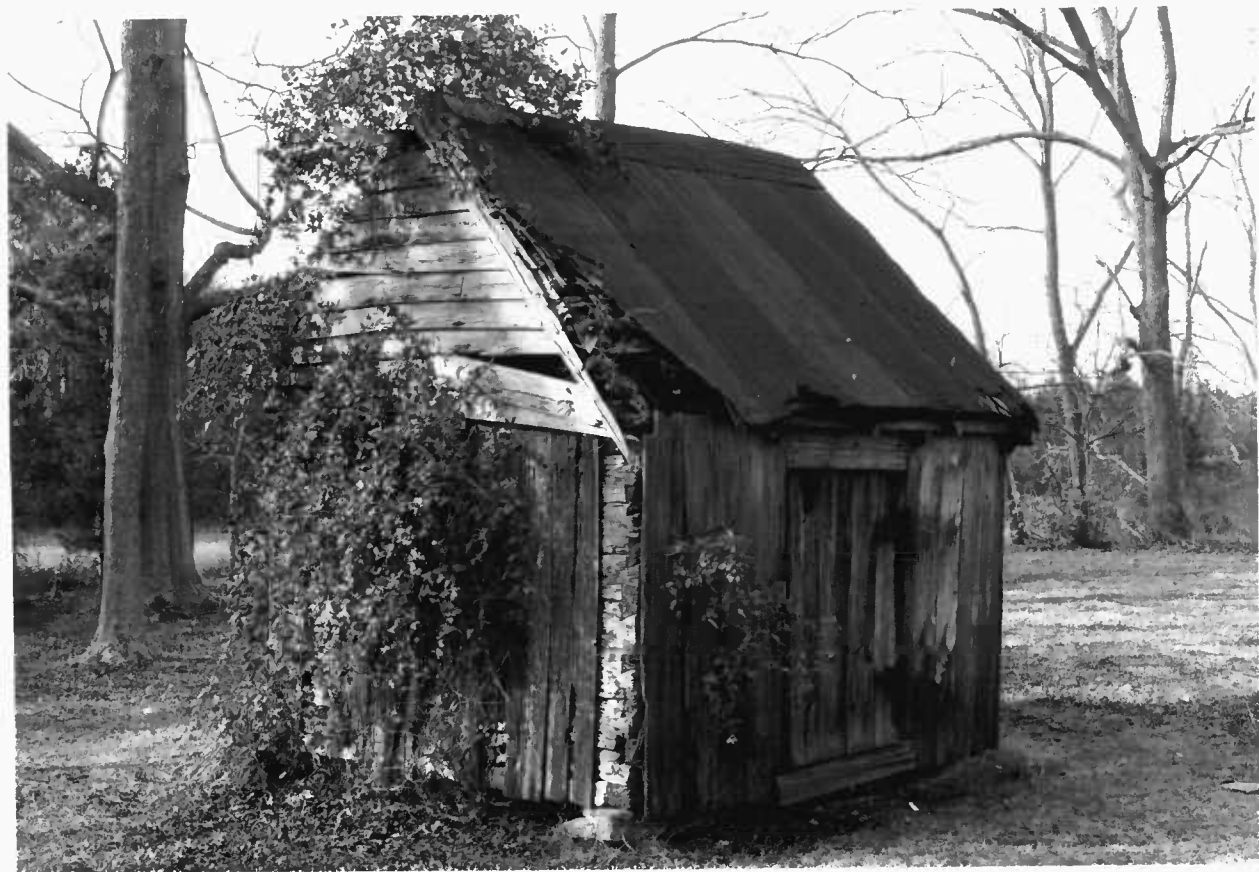
S-173

Smokehouse - Southeast Elevation

Located behind the house is a full-dovetailed log smokehouse with portions of vertical ship-lap siding fastened with wrought nails surviving on all four walls. Three corners of the ten by ten structure are supported by brick piers but a fourth corner (northeast) is still supported by a log slab.

The east side contains the only opening which is a board and batten door of circular sawn lumber and 20th-century strap hinges. Under the tin is a sheathing of wood shingles. The common rafter roof system is supported by a flat false-plate. In turn, the false-plate is supported by the floor joists. Wooden pins drop through the plate and butt-end of joists to stabilize the false-plate. The rafters' feet are fastened with wrought spikes. One tier of collar beams are let into each rafter pair with half-dovetail lap joints and fastened with wrought nails. The rafters are lapped and pinned. Each gable end is framed with a grid of studs and covered outside with weatherboards. All interior elements are smoke-blackened.

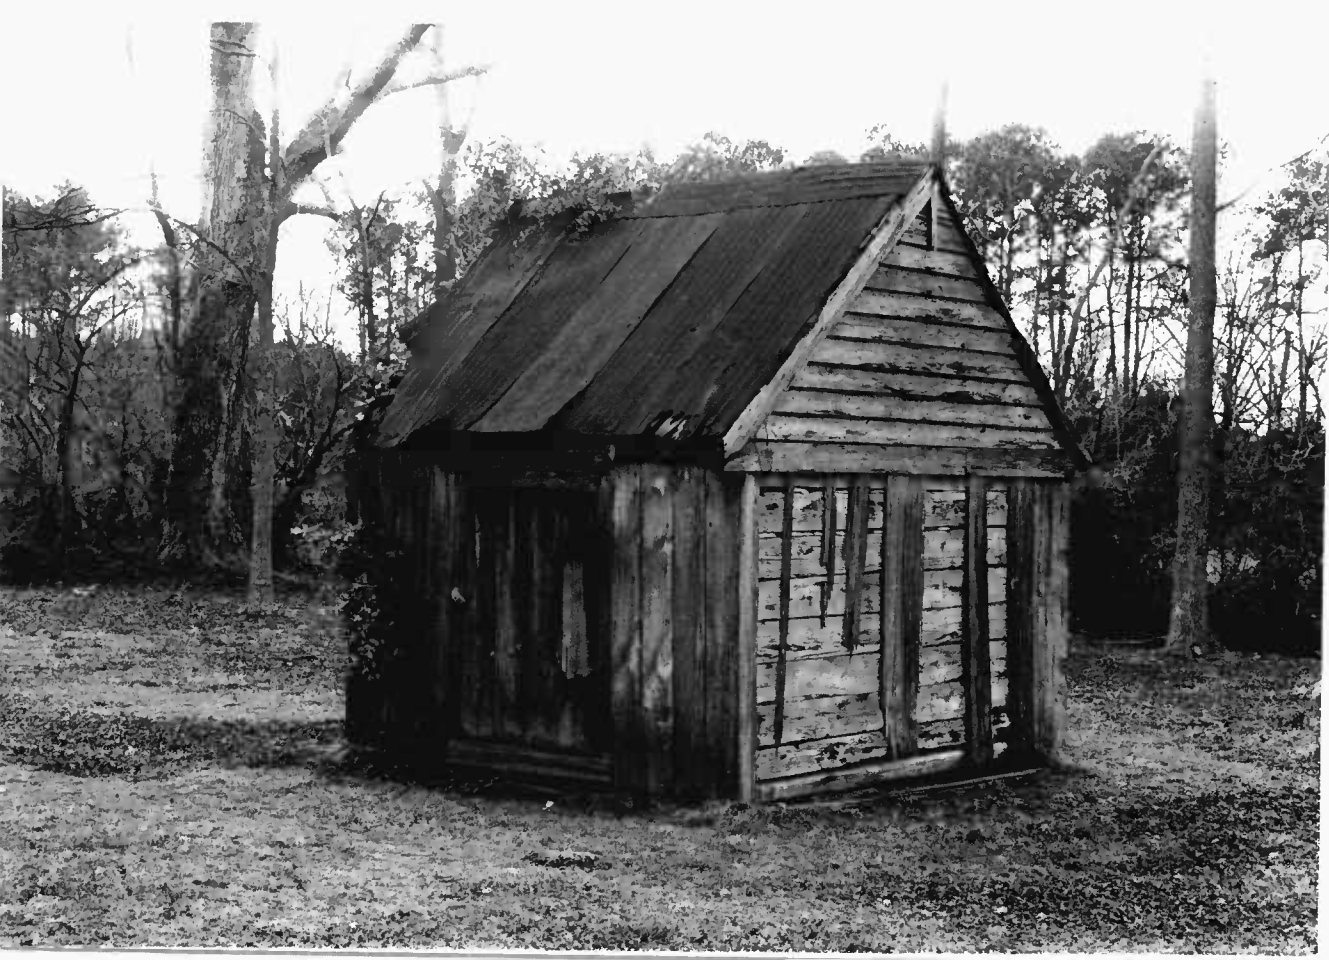
Thomas Sudler Farm S-173
Westover vicinity, Somerset Co., MD.
Smokehouse - Northeast elevation
11/83, Paul Touart, Photographer
Neg./ Md. Hist. Trust

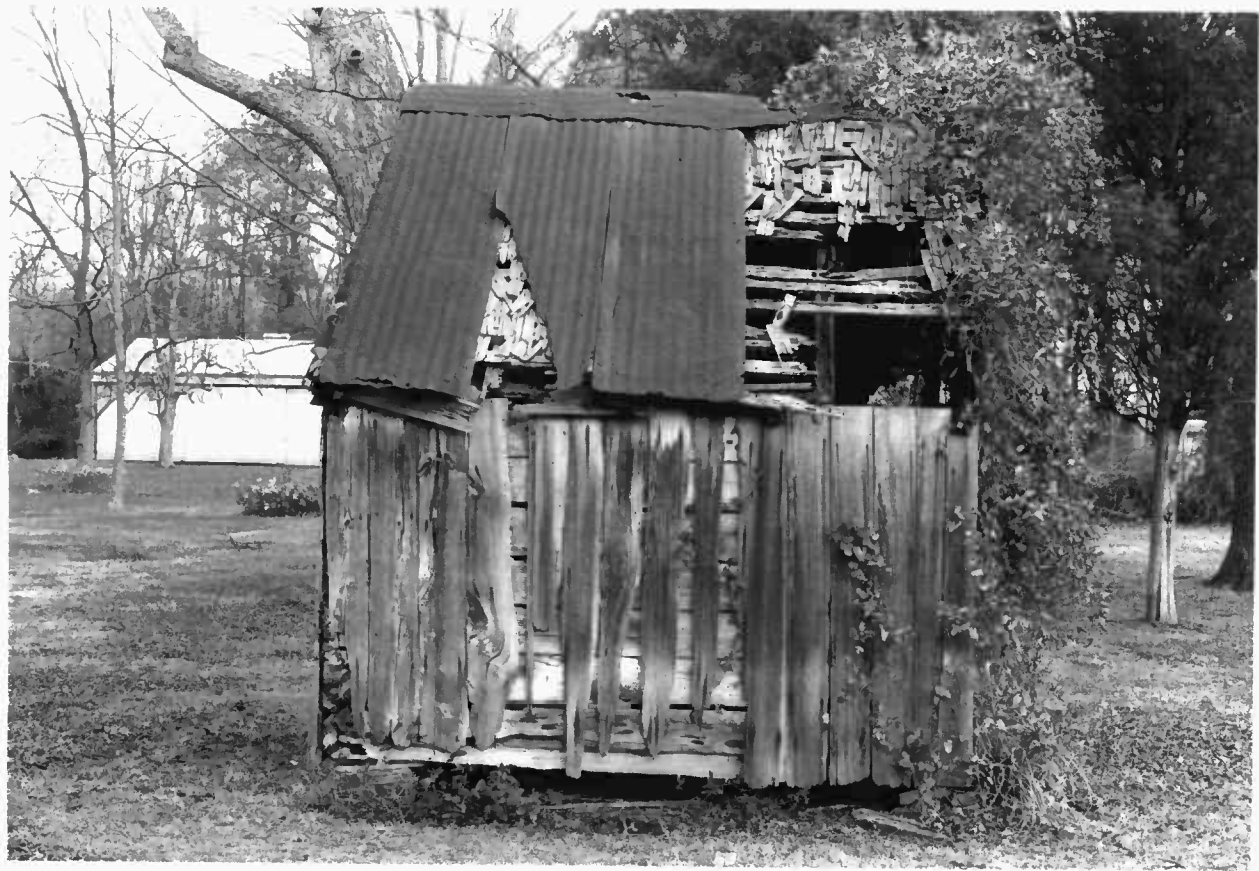
S-173

Smokehouse - West Wall

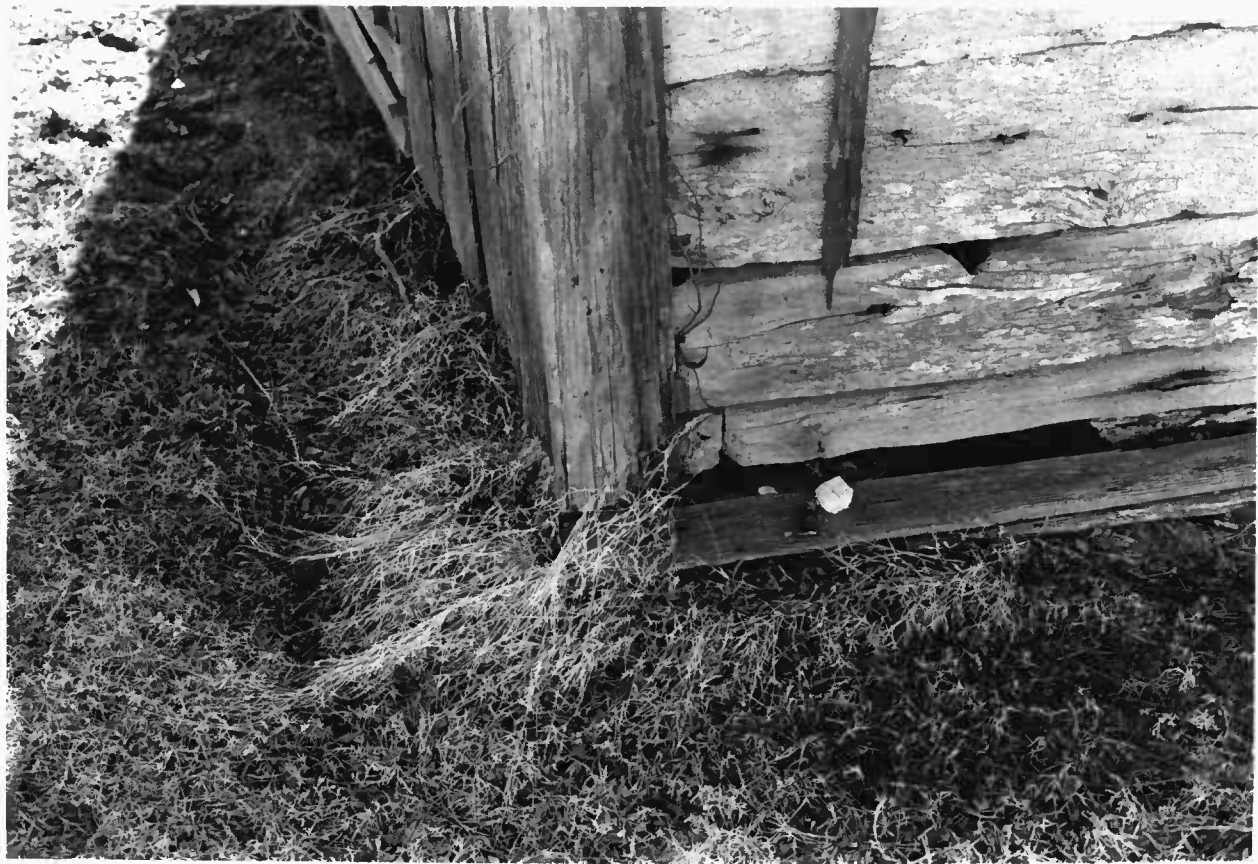
S-173

Thomas Sudler Farm
Near Westover, Somerset County
Smokehouse - Northeast Corner
2/84 Paul Touart
Neg./Md. Historical Trust

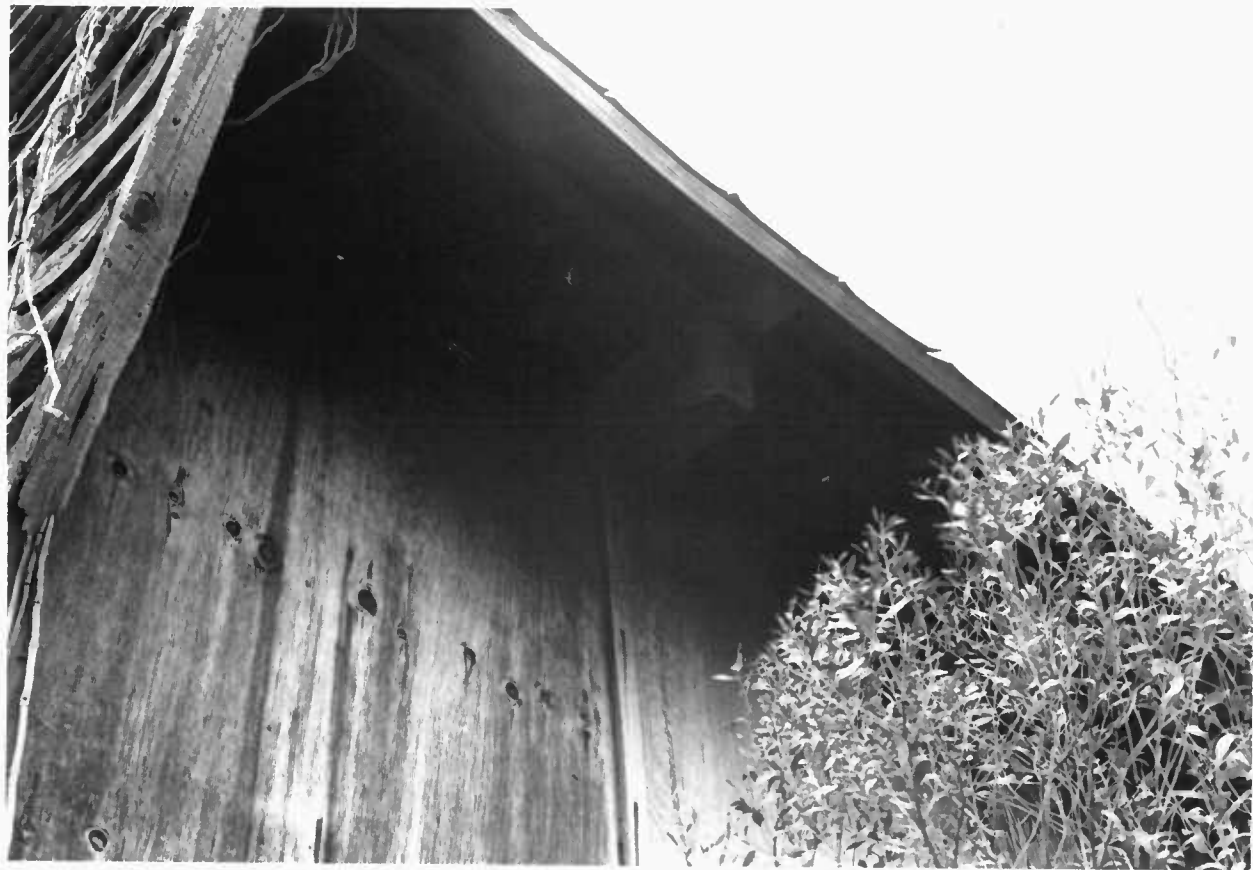
S-173

Thomas Sudler Farm
Near Westover, Somerset County
Barn Detail - South Wall
2/84 Paul Touart
Neg./Md. Historical Trust

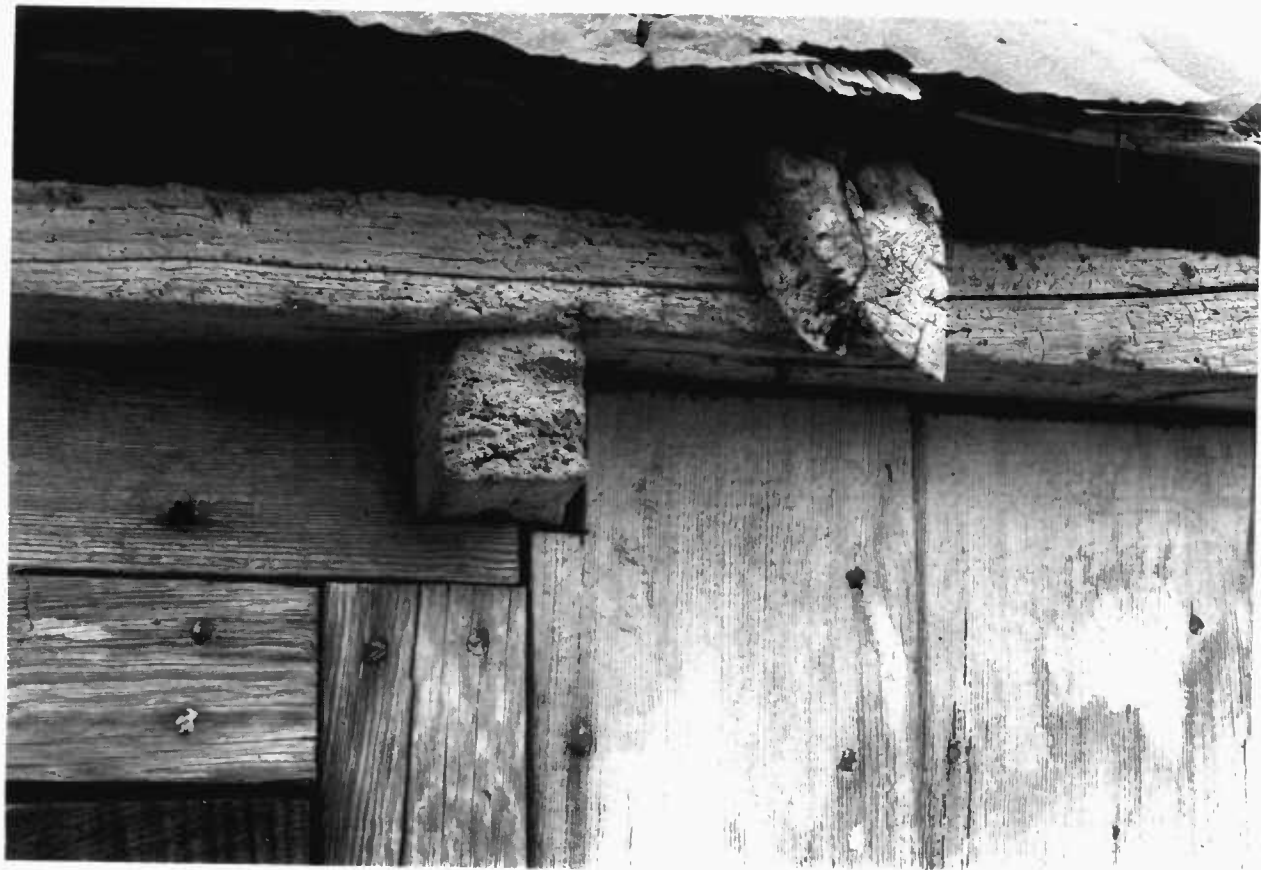
S-173

Thomas Sudler Farm
Near Westover, Somerset County
Smokehouse - Eave Detail
2/84 Paul Touart
Neg./Md. Historical Trust

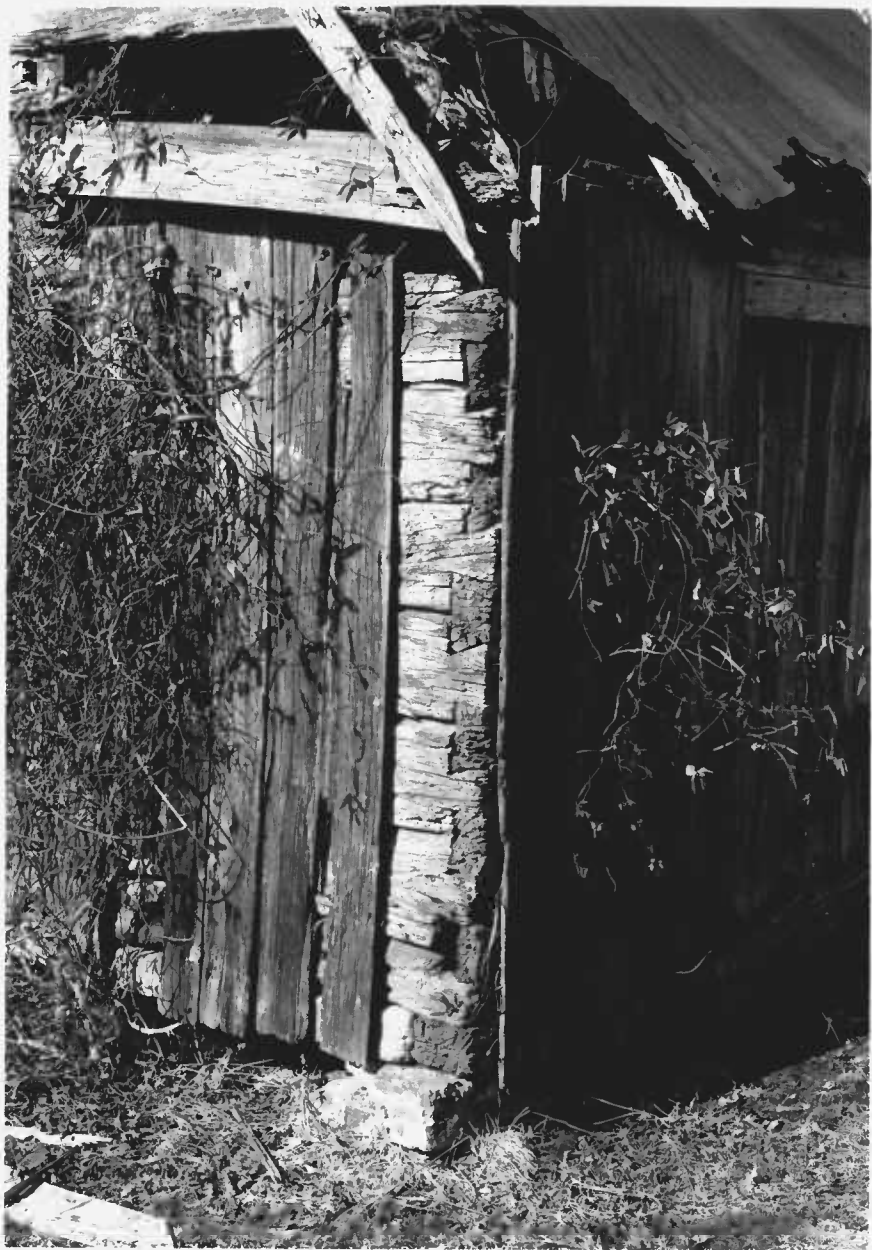
S-173

Thomas Sudler Farm
Near Westover, Somerset County
Smokehouse - Southeast Corner
2/84 Paul Touart
Neg./Md. Historical Trust

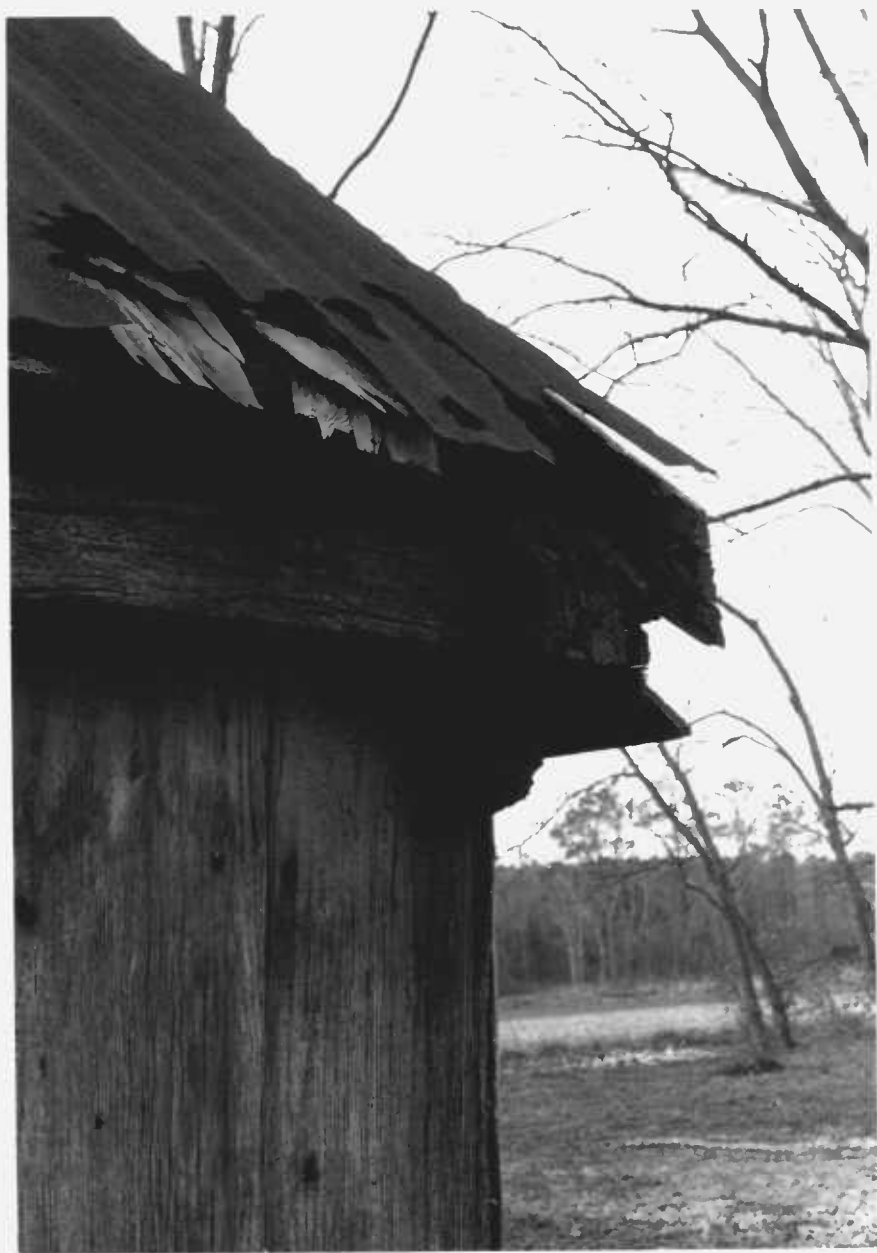
S-173

Thomas Sudler Farm
Near Westover, Somerset County
Smokehouse - Eave Detail
2/84 Paul Touart
Neg./Md. Historical Trust

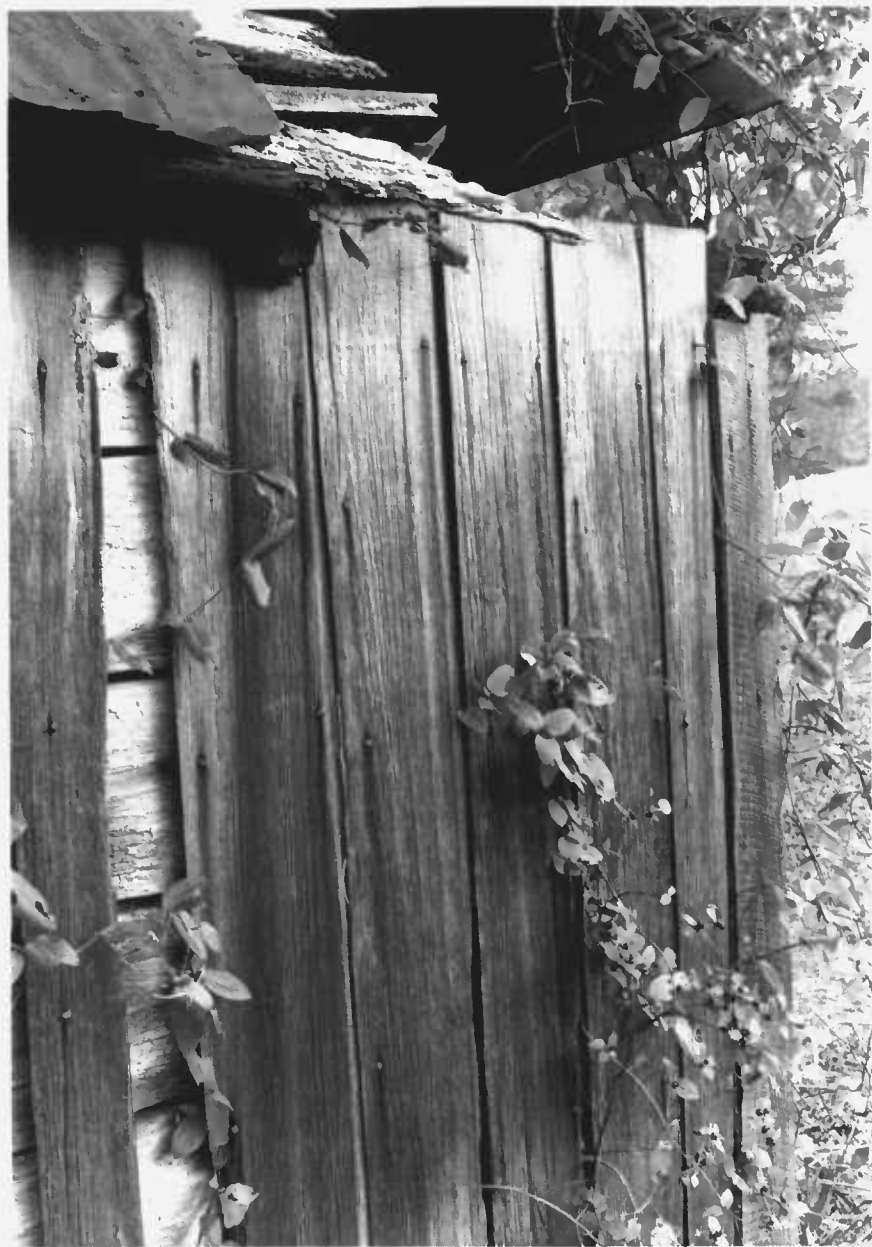
S-173

Thomas Sudler Farm
Near Westover, Somerset County
Smokehouse - West Wall
2/84 Paul Touart
Neg./Md. Historical Trust
